# Navajo Abandoned Uranium Mine

# Site Screen Report

## Mesa II Pit AUM Site

March 2010

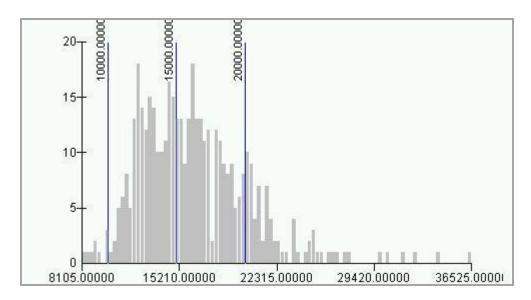
#### **Distribution Chart and Statistics:**

The following chart and statistics were generated by ESRI ArcGIS 9.3.1, and show the general distribution of the site gamma radiation measurements. The horizontal X axis represents the gamma radiation reading levels in cpm (lowest levels to the left). The vertical Y axis represents the frequency of each gamma radiation level.

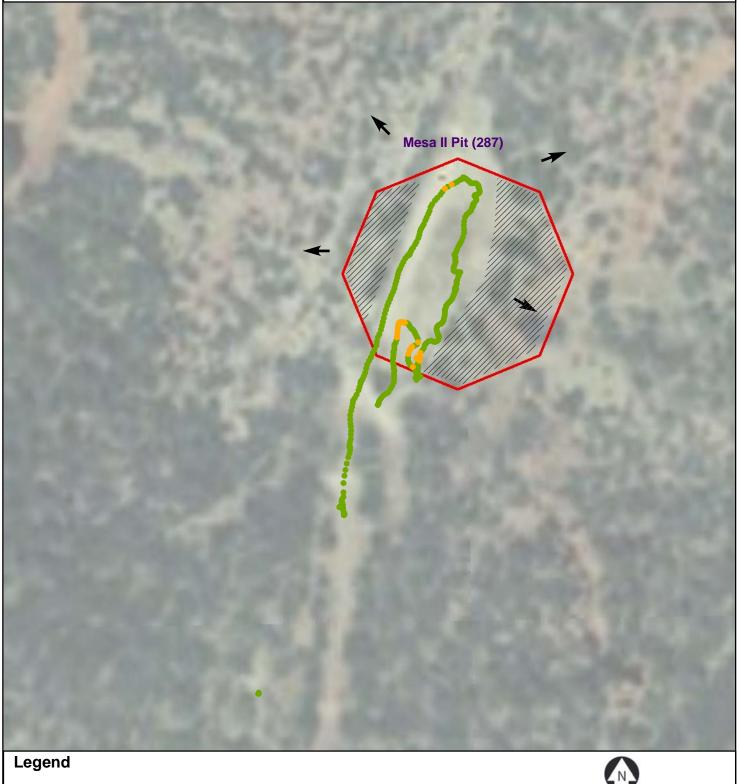
Figure 1 - Gamma Radiation Measurements, Above Two Times Background
Mesa II Pit (287)
Cove Chapter, Navajo Nation, Arizona

A total of 446 gamma radiation measurements were collected from the mine site, ranging from 8,105 cpm to 36,525 cpm. The measurements are represented in Figures 1 and 2.

Gamma survey conducted 10/2009 Measured as counts per minute (cpm)

Average background = 11,120 cpm

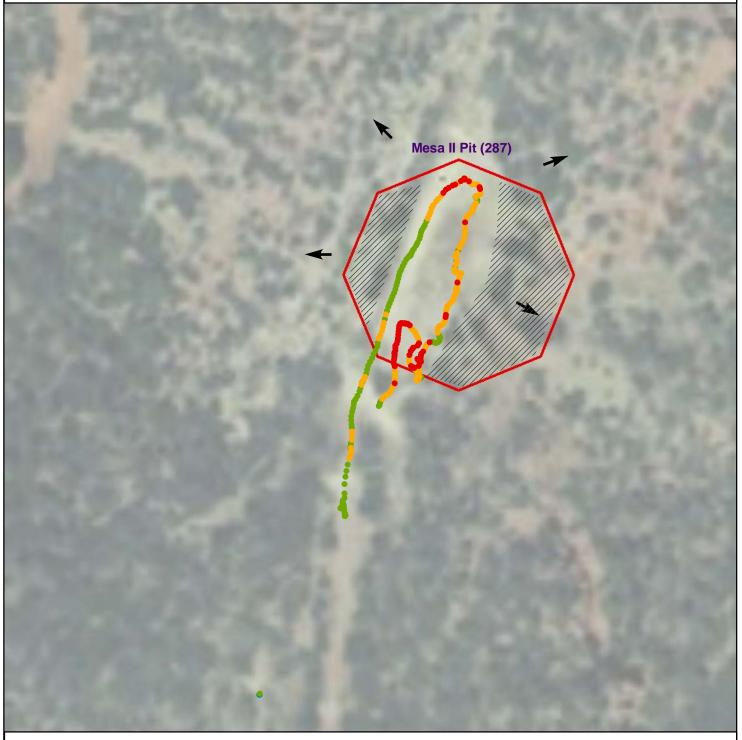
Figure 2 - Gamma Radiation Measurements Mesa II Pit (287) Cove Chapter, Navajo Nation, Arizona

Gamma survey conducted 10/2009 Measured as counts per minute (cpm)

Average background = 11,120 cpm
